Surfside Water Department Water System Manager's Report

Report On Water System Operations For The Month Of: **June 2015**

SURFSIDE HOMEOWNERS ASSOCIATION
PACIFIC COUNTY WASHINGTON

DBP PILOT STUDY REPORT

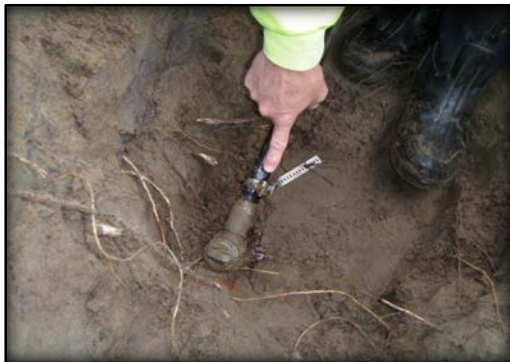
June 29, 2015 - 10 GPM

The Crew, with the assistance of attentive members, have found and repaired 14 water main leaks in 2015. They are listed below:

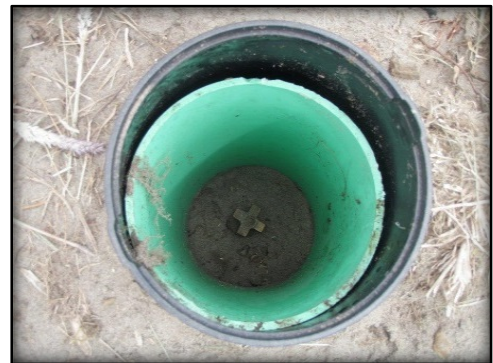
June 10, 2015 - 4 GPM

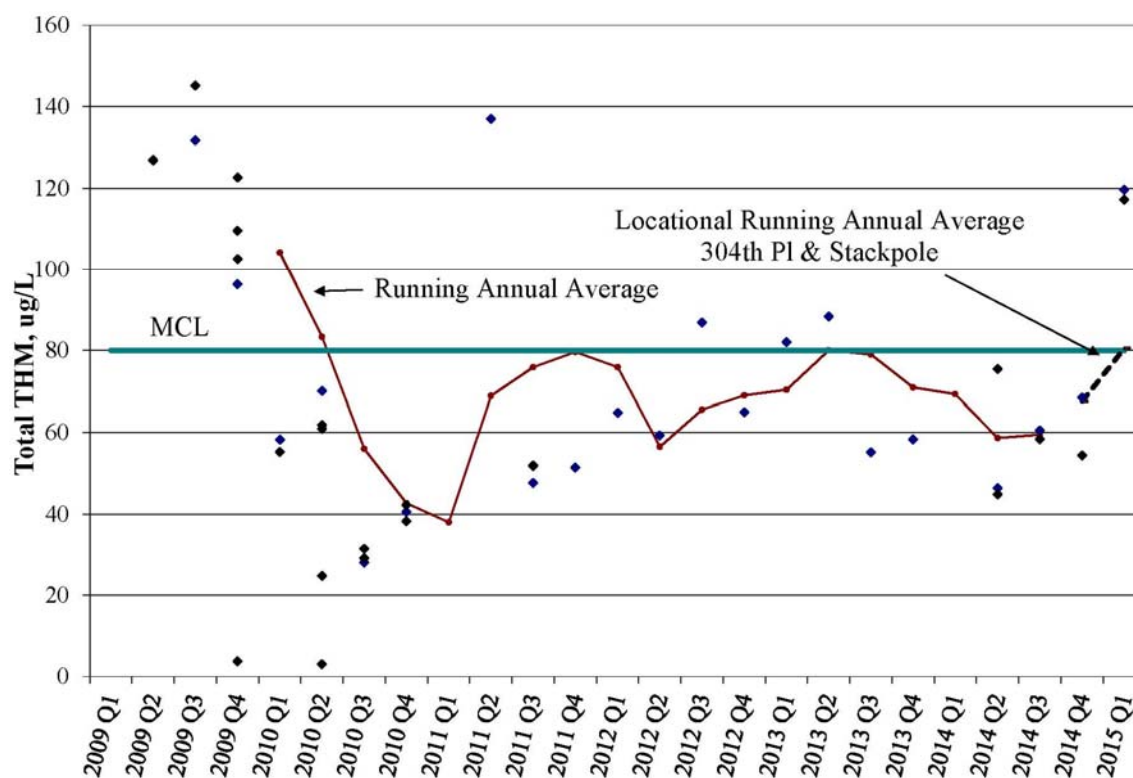
FIGURE 1-1

THM Data for Surfside Homeowners Association

concentrations and that the principal contributor to the THMs is the chlorine added for disinfection.

Surfside began taking quarterly DBP samples starting in 2009 including trihalomethane (THM) samples. The four THM constituents are chloroform (CHCl₃), bromochloroform (CHBrCl₂), chlorodibromochloroform (CHBr₂Cl), and bromoform (CHBr₃). Figure 1 shows the quarterly sampling results and the running annual average.

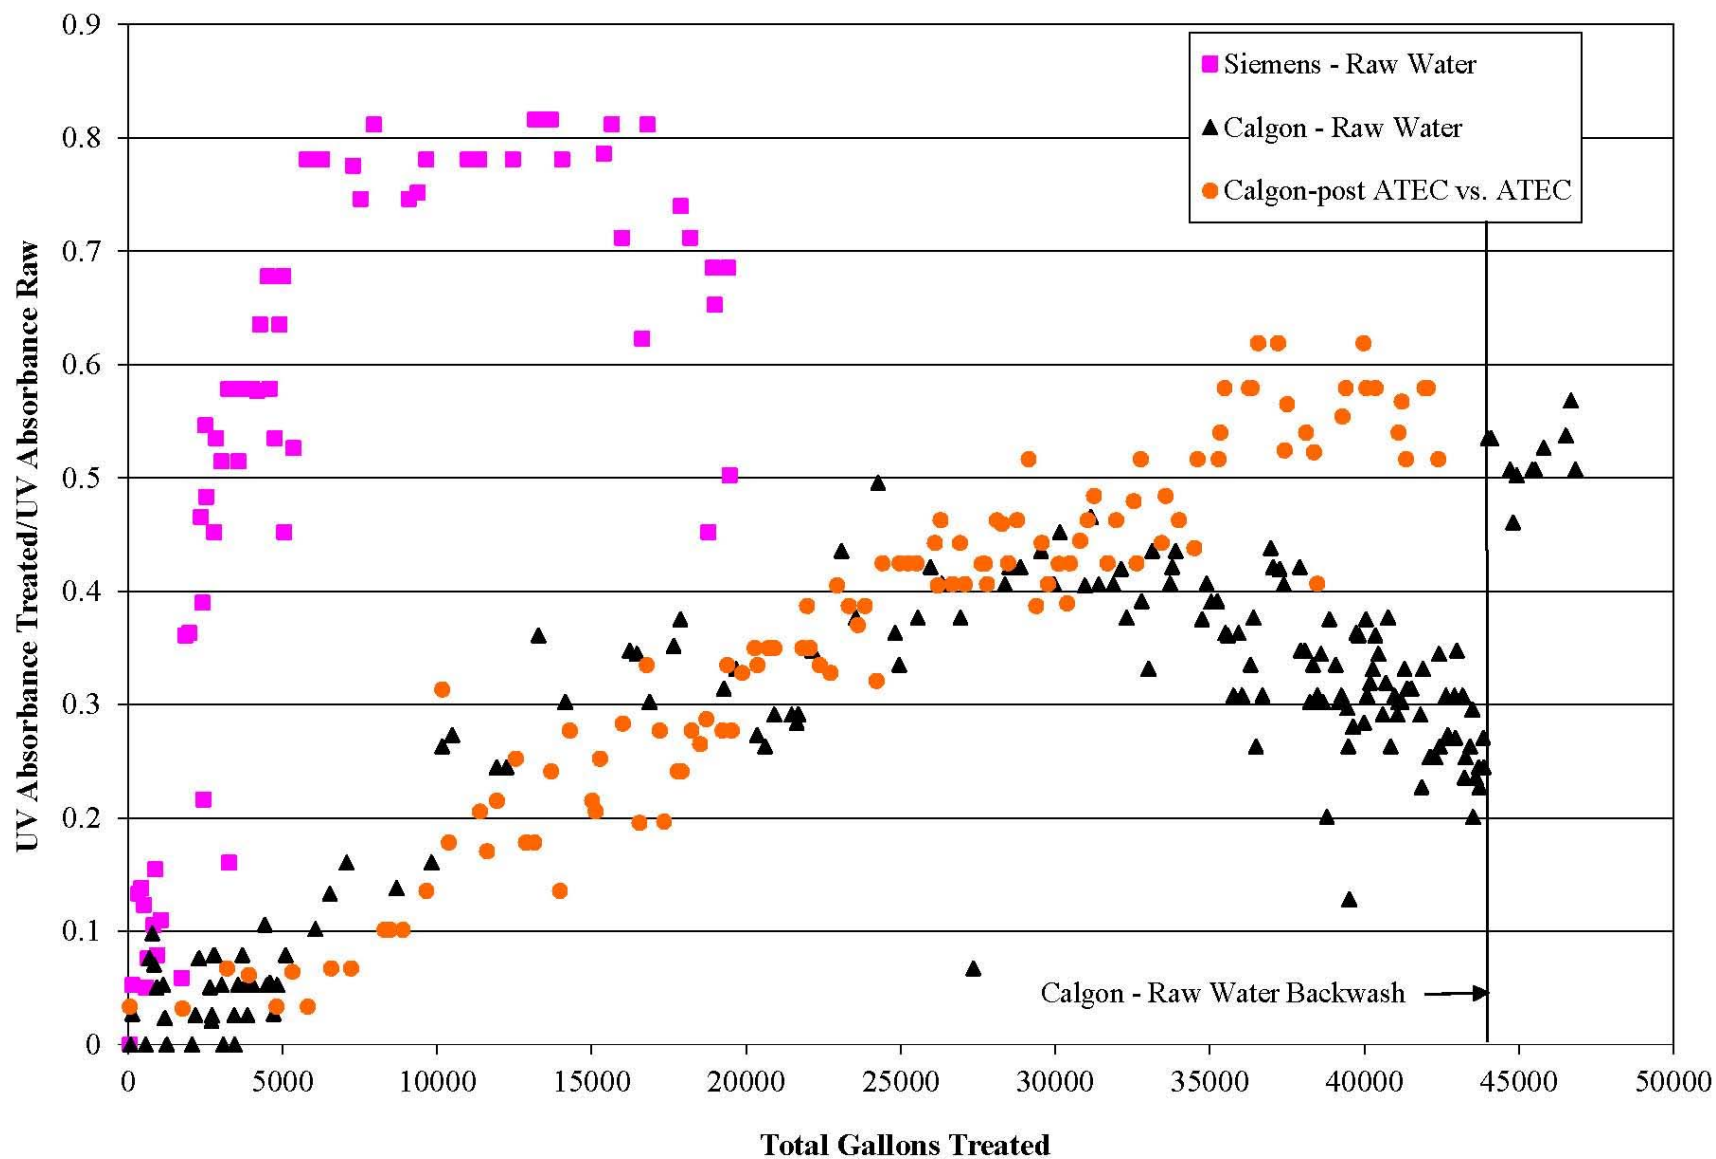
FIGURE 3-3

Figure 3-3 shows the results of the comparison of the two carbons as well as a second Calgon carbon installed post-ATEC further described below. The y-axis is the ratio of the UV absorbance of the treated water over the UV absorbance of the raw water. Since the correlation of UV absorbance to MTTFP is very good, the y-axis is analogous to concentration of THM precursors in the treated water over concentration of THM precursors in the raw water (C/C_0). The data show that a difference in performance was apparent almost immediately. The Siemens carbon showed a rapid decrease in performance starting with almost complete removal of THM precursors but them

**Comparison of Carbon Performance as Measured by UV Absorbance
Comparison Between Treated and Raw Water Over Treated Volume**

One of the goals of the pilot study was to determine if one of the two commercial carbons would perform better in this application than the other. This assessment was made by comparing the UV 254 absorbance readings for the two carbons sampled at sample port 8, the outlet of the lag column, for each column system.

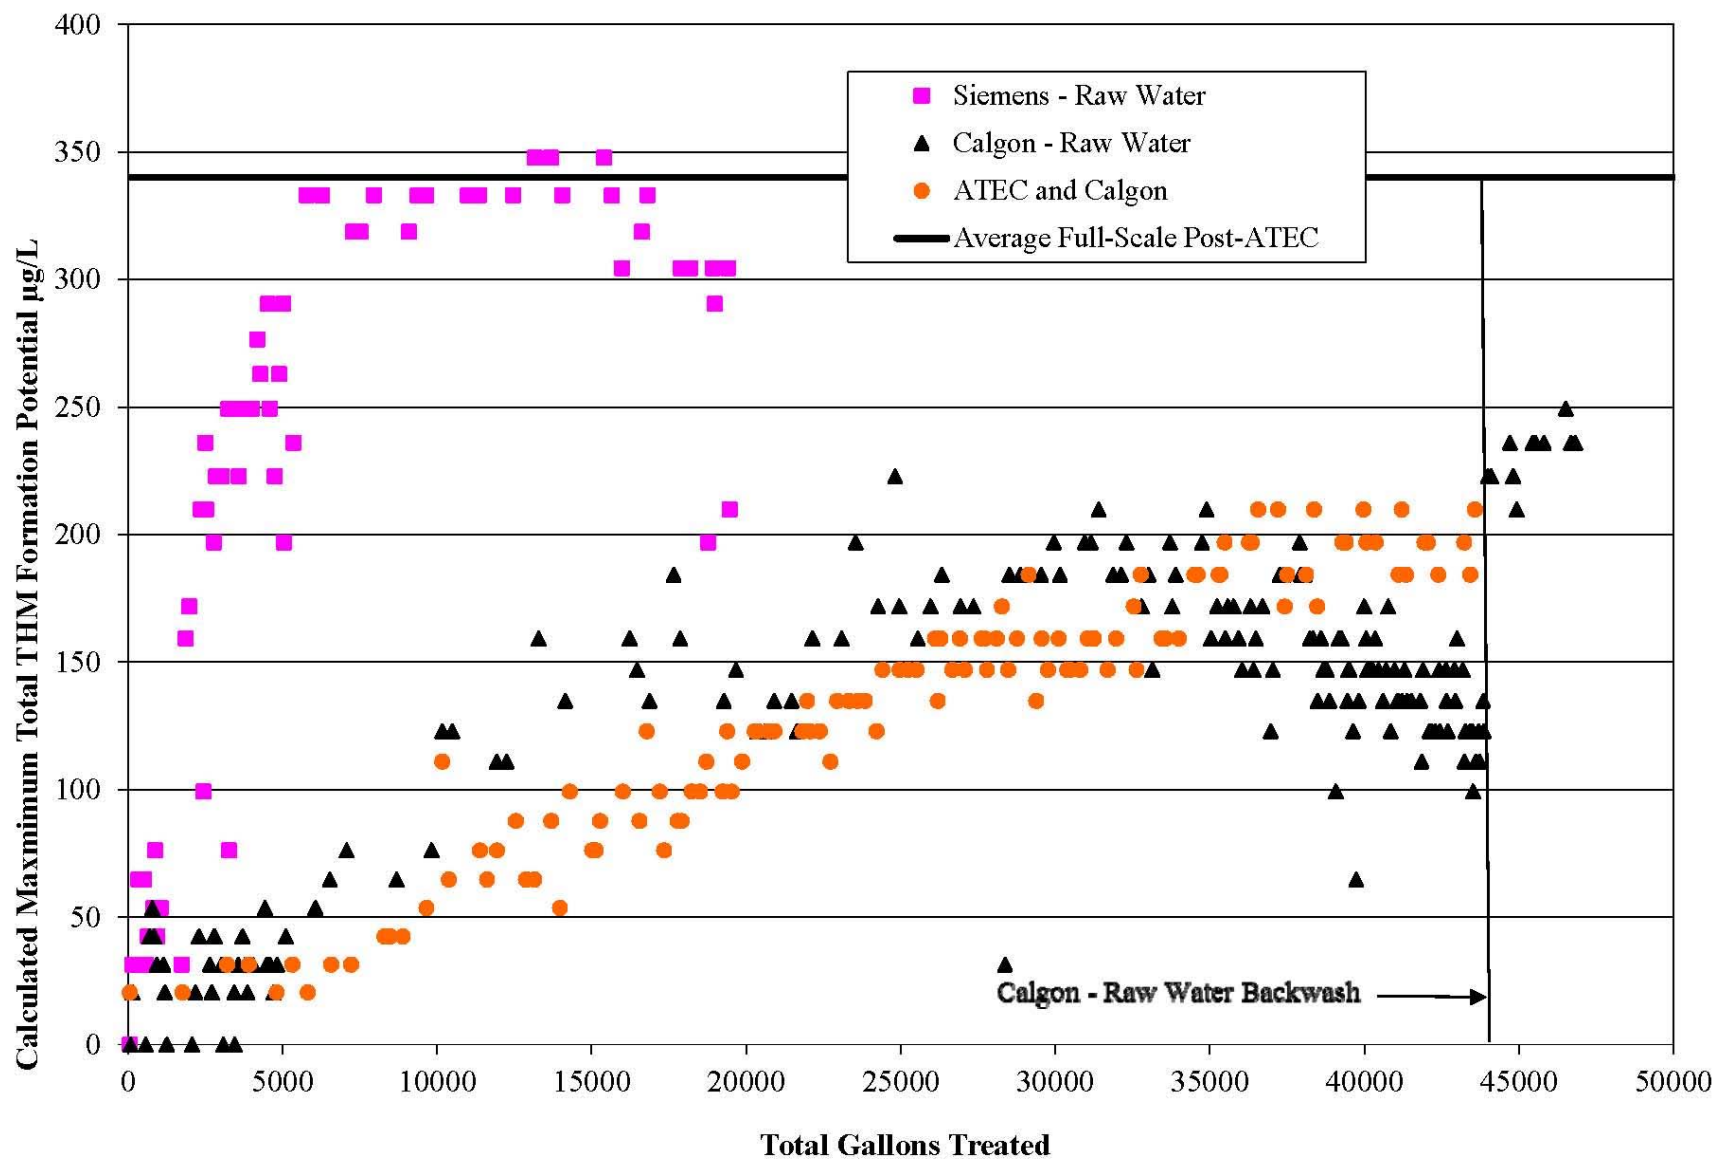
FIGURE 3-4

Calculated Maximum Total THM Formation Potential (from UV Data)
Over Treated Volume for the Three Carbons Tested
